**Mount Allison  
Dendrochronology Lab**

Mad Lab Report 2006-26

A Dendroarcheological Analysis of William Black Memorial Church:  
Glen Margaret, Nova Scotia

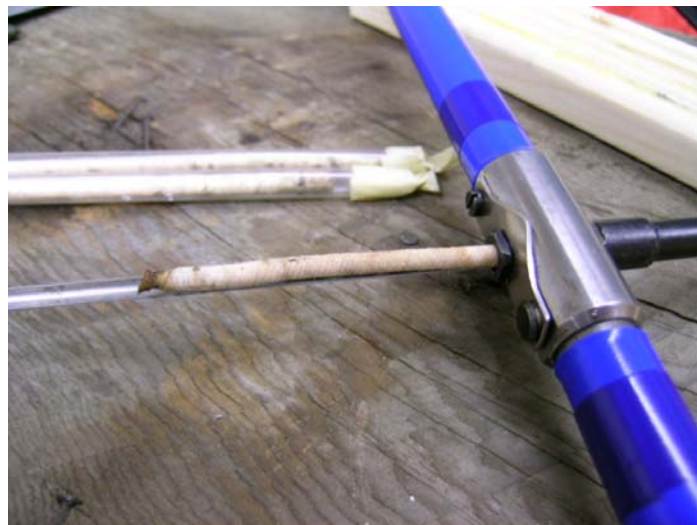
**Figure 2:** Sample extracted with an increment borer.

Fourteen samples were taken from a total of ten beams using an increment borer (see Appendix A). The diameter of each sample is 4.3 mm, approximately the size of a pencil (Figure 2). The sampling process has no negative effects on the structural integrity of the building. All of the beams sampled are located underneath the church, where they have not been altered since the initial construction of the church. Beams were selected for sampling according to their integrity (the absence of rot) and the presence of bark (indicating the last tree-ring has not been removed in the construction of the church).

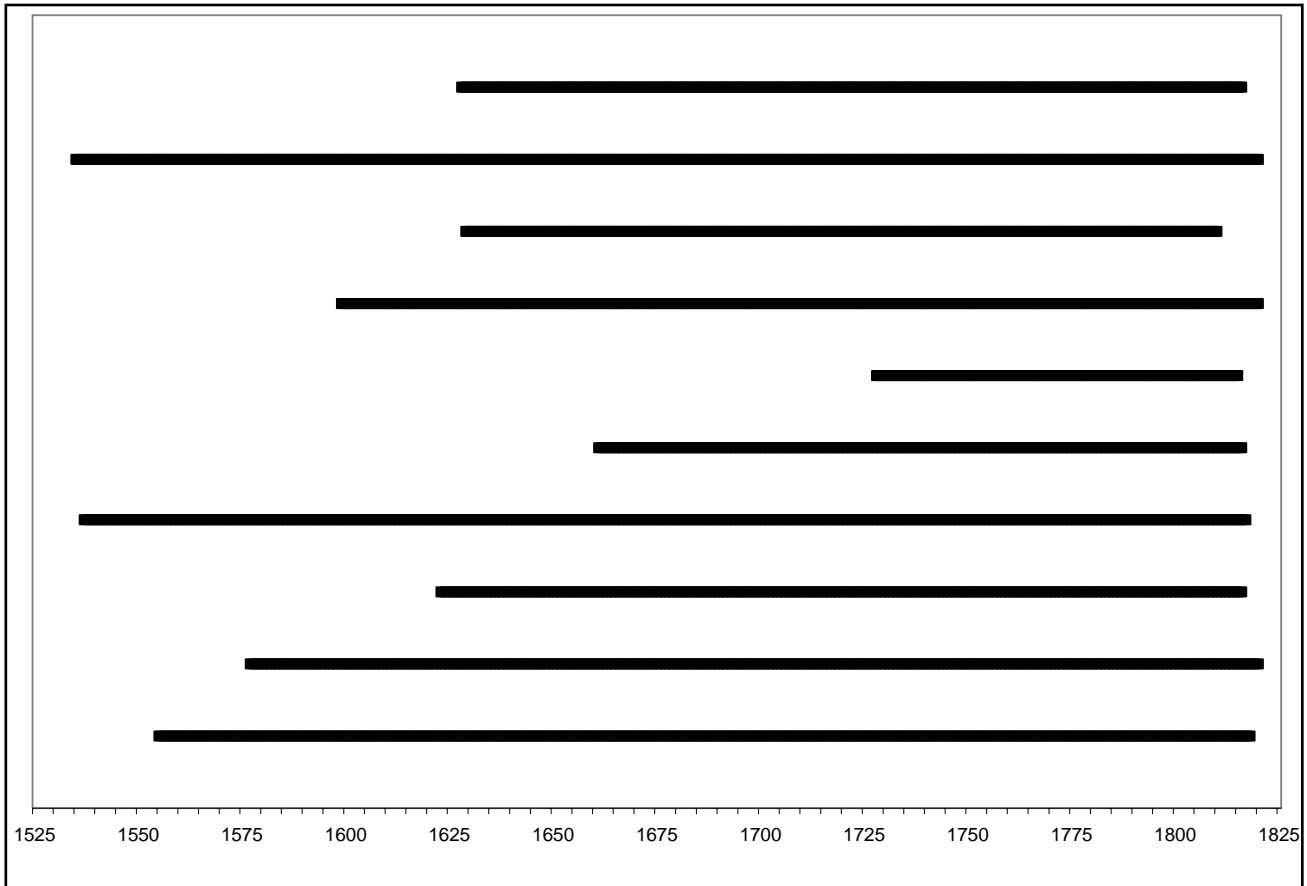
**Figure 3:** Life-spans of trees within beams of William Black Memorial Church.

Based on an analysis using COFECHA, it was determined that the last year of growth of the trees within the church beams was 1820 (Figure 3, Table 1). This suggests that the trees used in the construction of the church were cut down with the last growing year being 1820, approximately a year before the building was constructed. Based on construction and logistical

schedules of the time, it is reasonable to believe that the trees were felled in the fall/winter of the year before construction began. This fact confirms the parishioners' records of William Black Memorial Church being constructed in 1821.

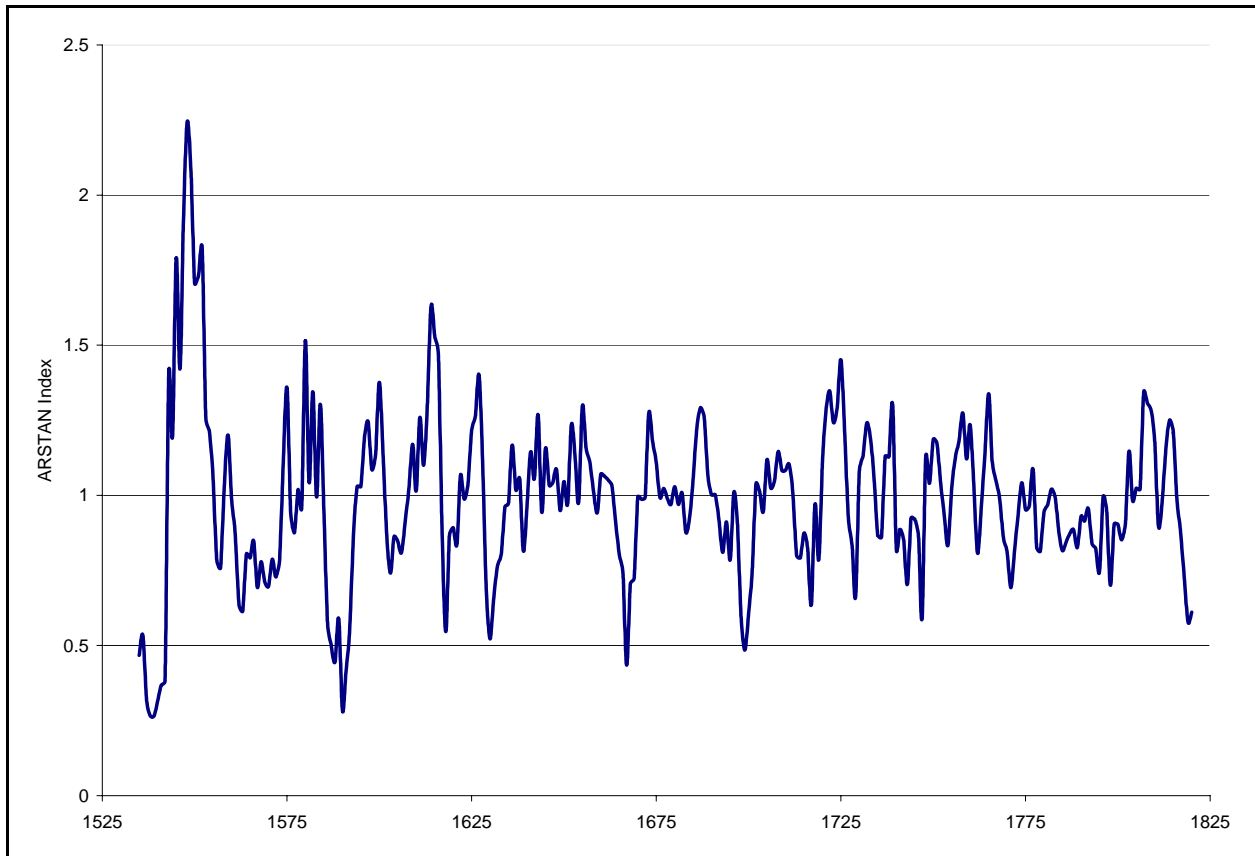
**Figure 4:** Floating chronology for eastern hemlock in William Black Memorial Church.

Once the cut years of the trees were determined, it was possible to create a floating chronology for the “stand” (Figure 4). This shows the average growth patterns for all of the eastern hemlock samples within the beams of the church.

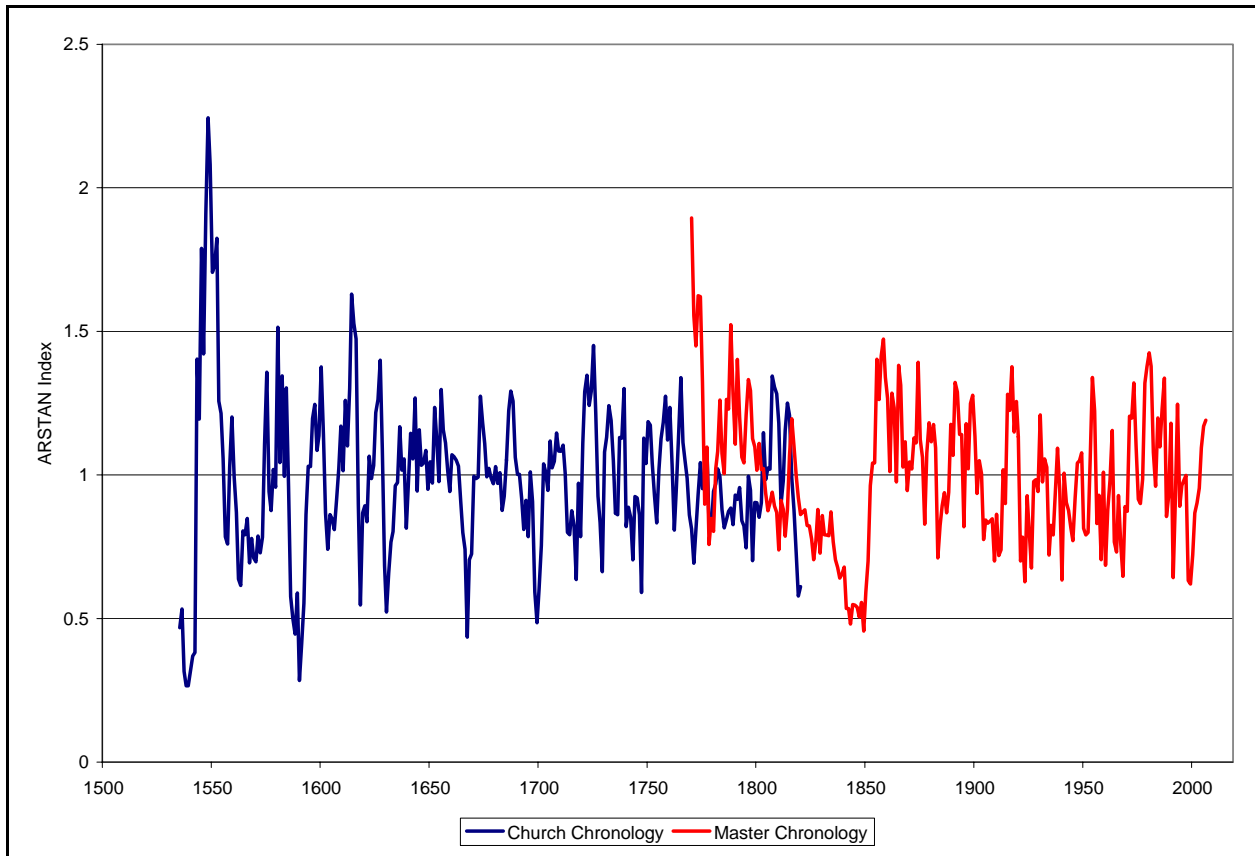
**Figure 5:** Overlap of the living and church chronologies shows similar growth patterns.

The beams from this church effectively contribute to the project’s objective (Figure 5). There is enough overlap between the live eastern hemlock stand and the eastern hemlock samples within the church to ensure a significant correlation. All beams crossdate into the live chronology with a significance ranging from 0.351 – 0.592 (99% confidence of significance at 0.3281). However, most of the church chronology does not overlap with the live chronology. This allows most of the growth-years of the trees within the beams to extend the total record of eastern hemlock growth-patterns in southwestern Nova Scotia back hundreds of years further than would be possible with live trees alone.

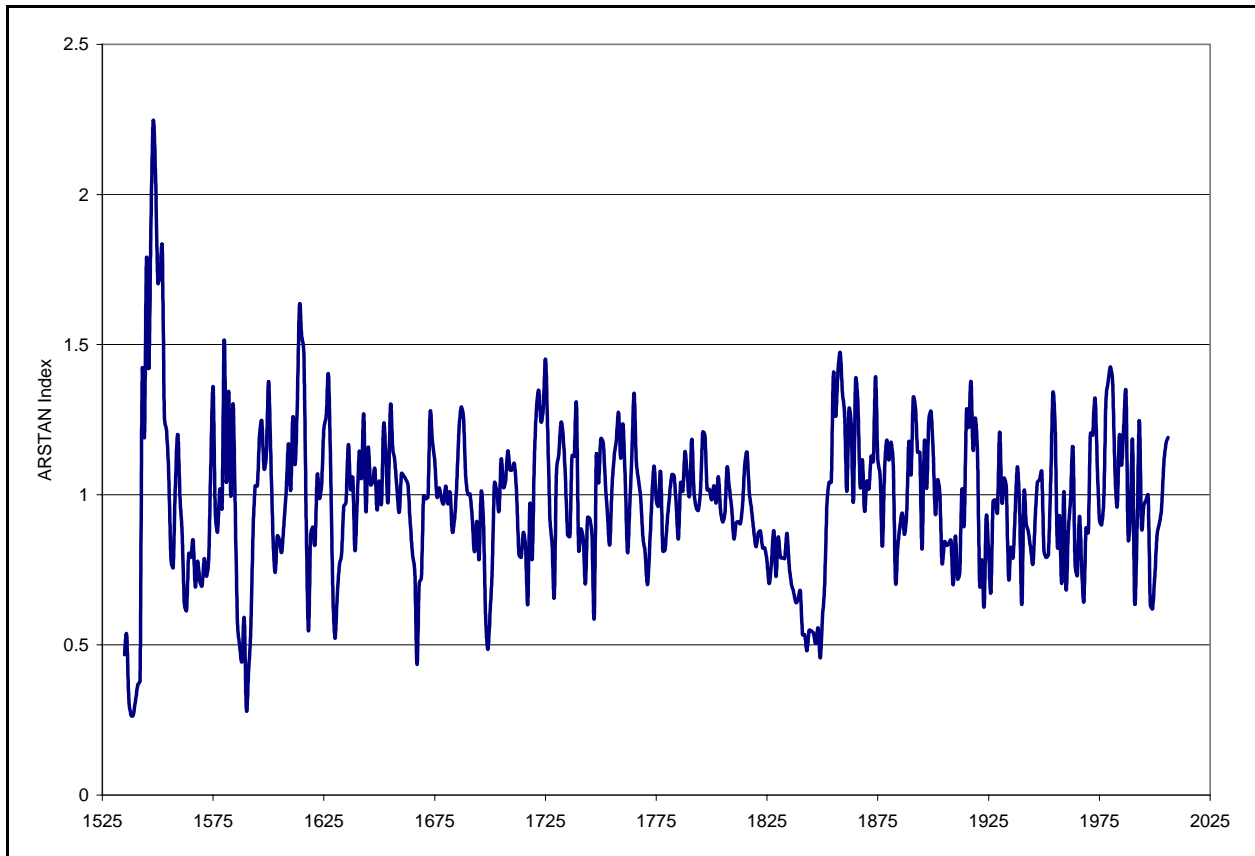
**Figure 6:** Master chronology for eastern hemlock in southwestern Nova Scotia.

From this it was possible to develop a master chronology for eastern hemlock in southwestern Nova Scotia (Figure 6). The overall correlation of this chronology is 0.529, which is much higher than the 0.3281 required for 99% confidence of significance.

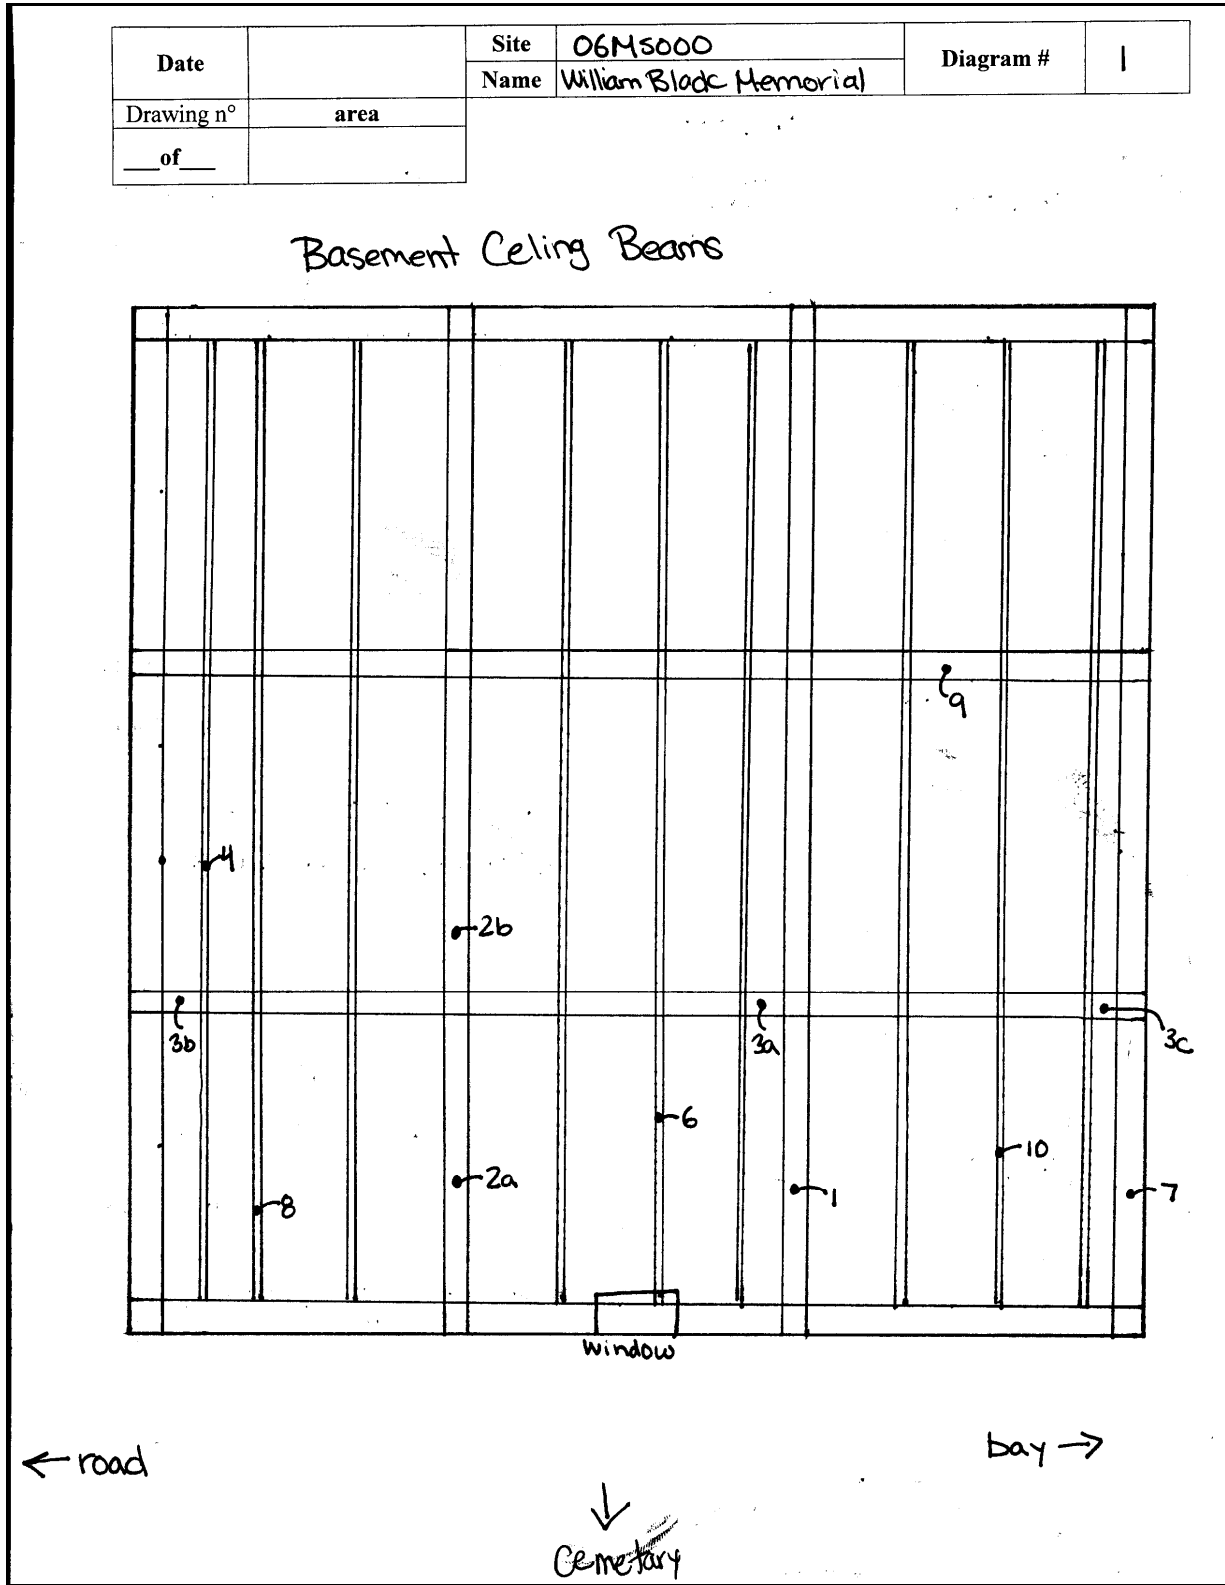
Appendix A: Diagram of William Black Memorial Church crawlspace.
