**Mount Allison
Dendrochronology Lab**

Mad Lab Report 2006-30

A Dendroarcheological Analysis of Zion Baptist Church:
Yarmouth, Nova Scotia

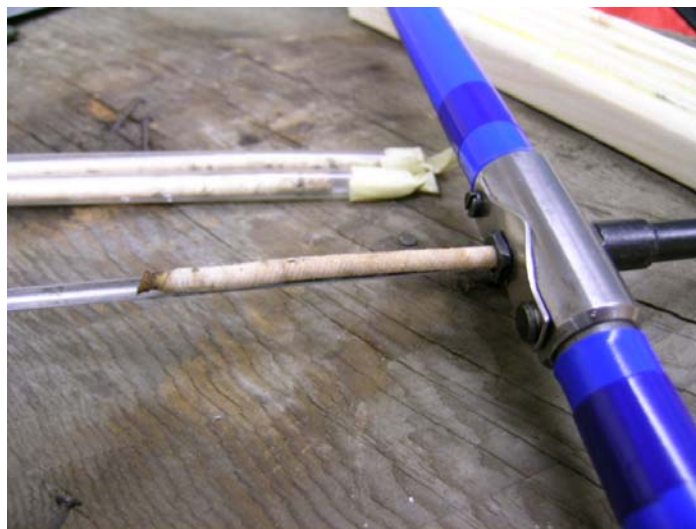
Figure 2: Sample extracted with an increment borer.

Samples were taken from a total of twenty beams using an increment borer (see Appendix A). The diameter of each sample is 4.3 mm, approximately the size of a pencil (Figure 2). The sampling process has no negative effects on the structural integrity of the building. All of the beams sampled are located in the church's basement, where they have not been altered since the initial construction of the church. Beams were selected for sampling according to their integrity (the absence of rot) and the presence of bark (indicating the last tree-ring has not been removed in the construction of the church).

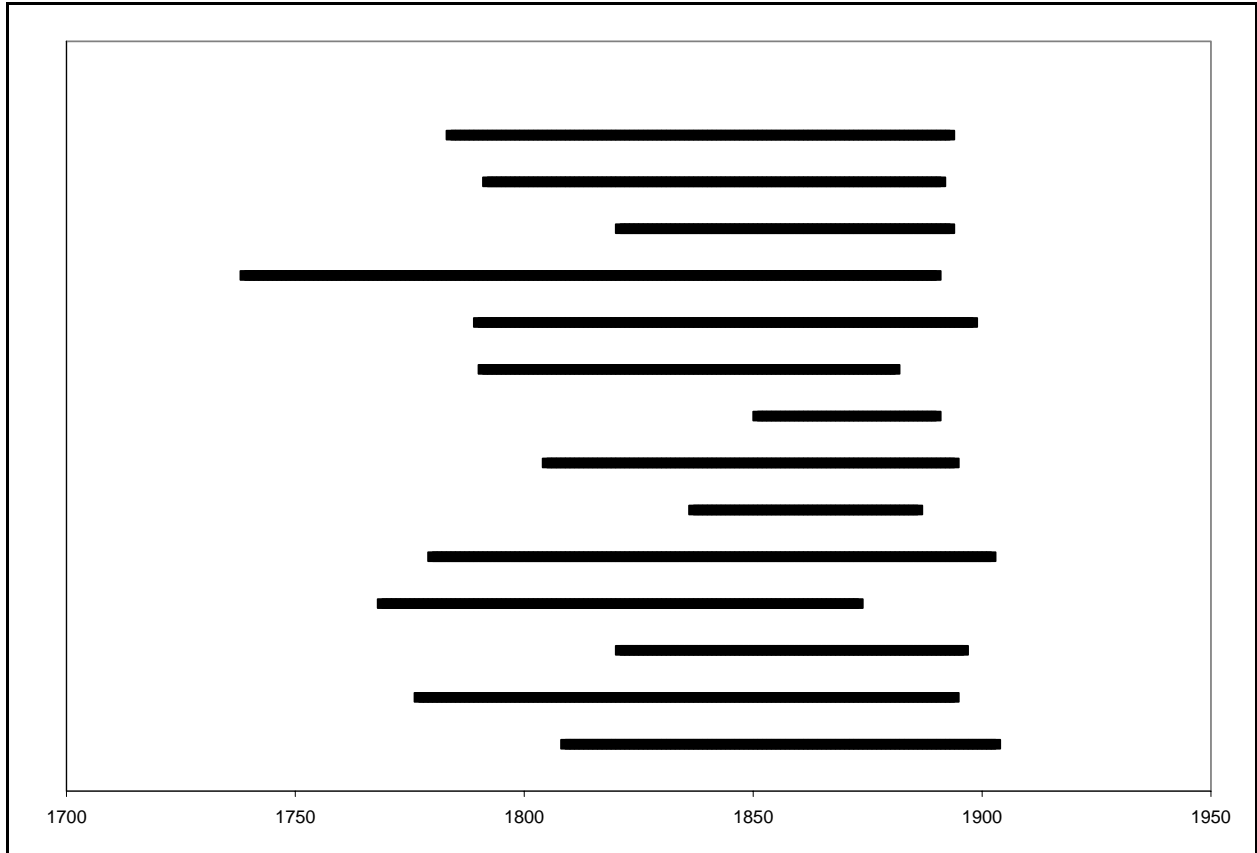
Figure 3: Life-spans of trees within beams in Zion Baptist Church.

Based on an analysis using COFECHA, it was determined that the last year of growth of the trees within the church beams ranged from 1894-1895 (Figure 3, Table 1). This suggests that the trees used in the construction of the church were cut down with the last growing years being 1894-95, approximately a year before the building was constructed. Based on construction and logistical schedules of the time, it is reasonable to believe that the trees were felled in the fall/winter of the year before construction began. This fact confirms the parishioners' records of Zion Baptist Church being constructed in 1895.

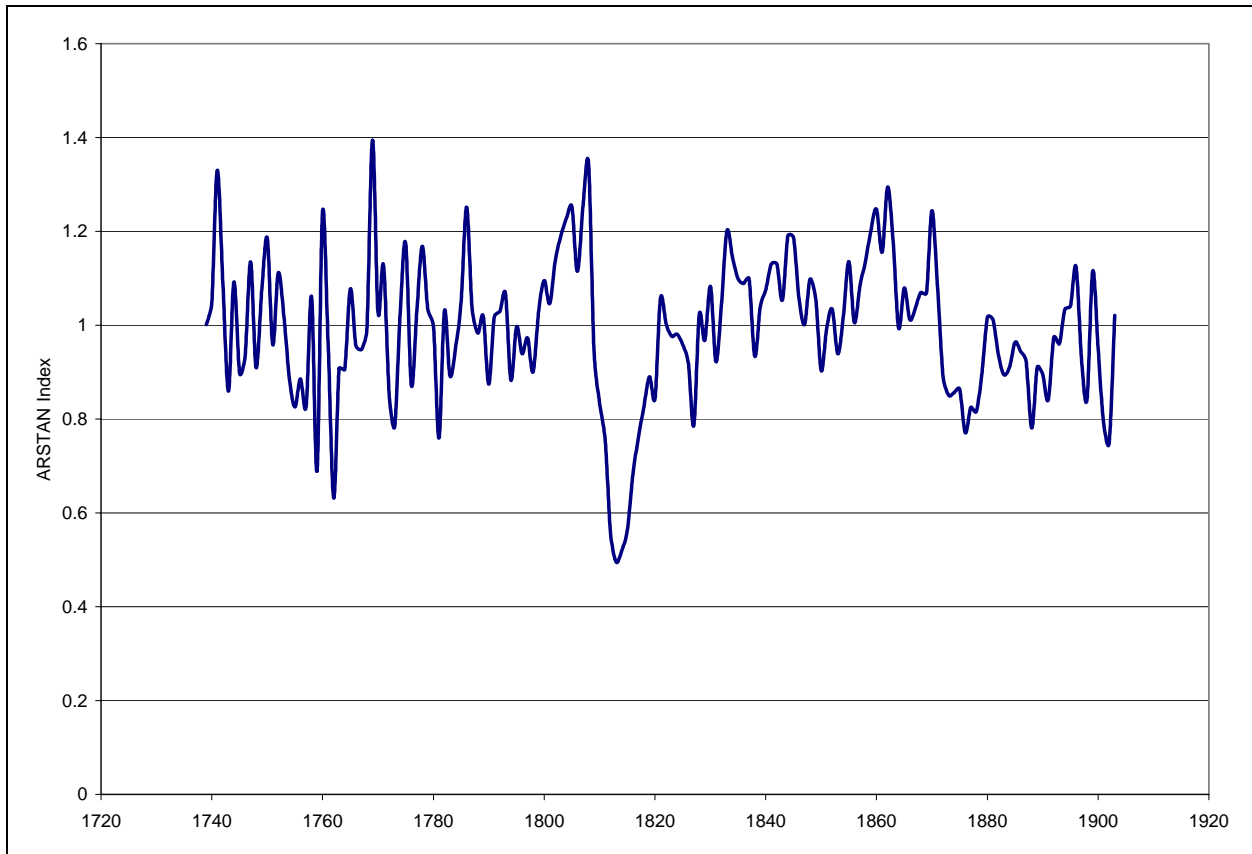
Figure 4: Floating chronology for red spruce in Zion Baptist Church.

Once the cut years of the trees were determined, it was possible to create a floating chronology for the “stand” (Figure 4). This shows the average growth patterns for all of the red spruce samples within the beams of the church.

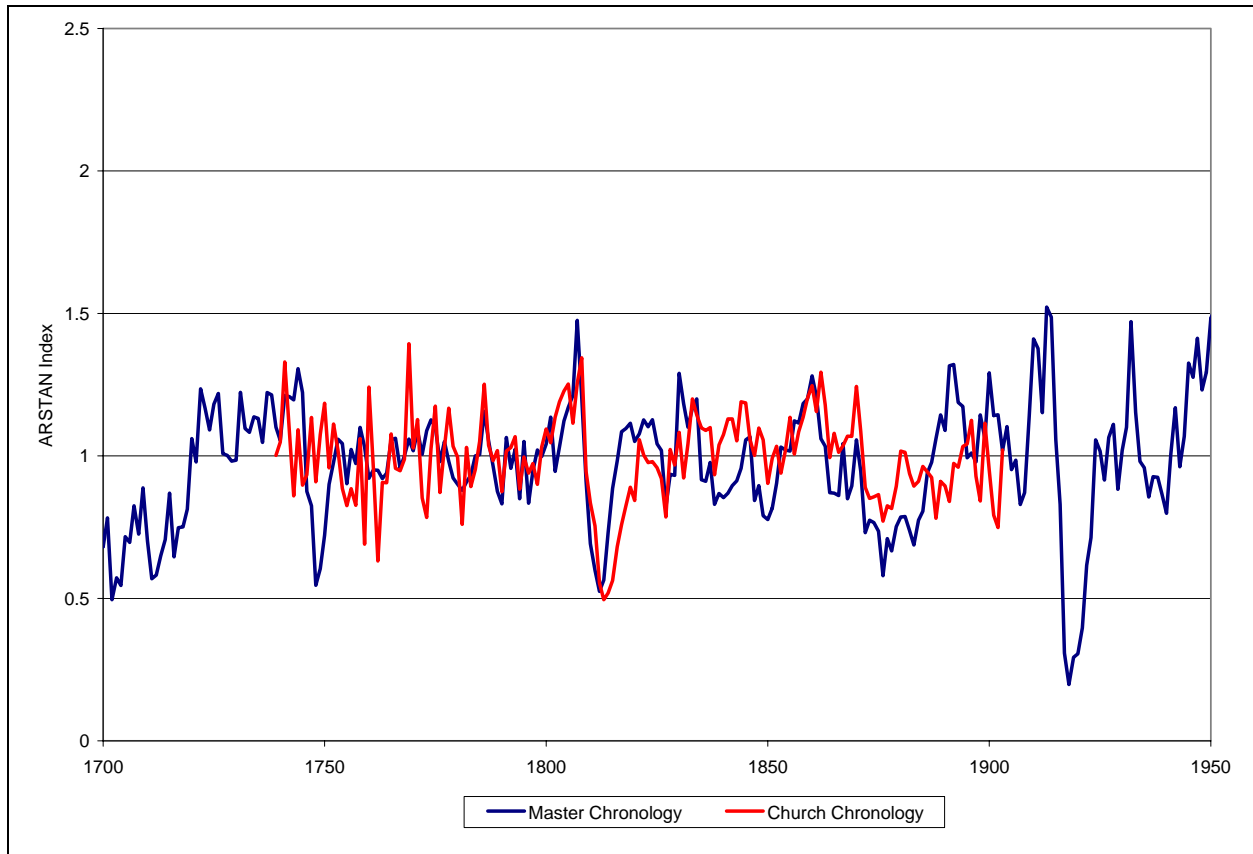
Figure 5: Overlap of the master and church chronologies shows similar growth patterns.

The beams from this church effectively contribute to the two of the project’s objectives which are to increase red spruce sample depth in Nova Scotia and to create a master chronology specific to southwestern Nova Scotia (Figure 5). All beams crossdate into the live chronology with a significance ranging from 0.133-0.378 (90% confidence of significance at 0.21). Out of the fourteen samples, nine achieve 90% significance or higher, with correlations to the live chronology above 0.21. The reason that the significance levels are not higher than 90% is likely that the live chronology is based predominately on red spruce trees growing in New Brunswick. The distance between the habitats of the live chronology and the stand that made up the church chronology may be the reason for this discrepancy.

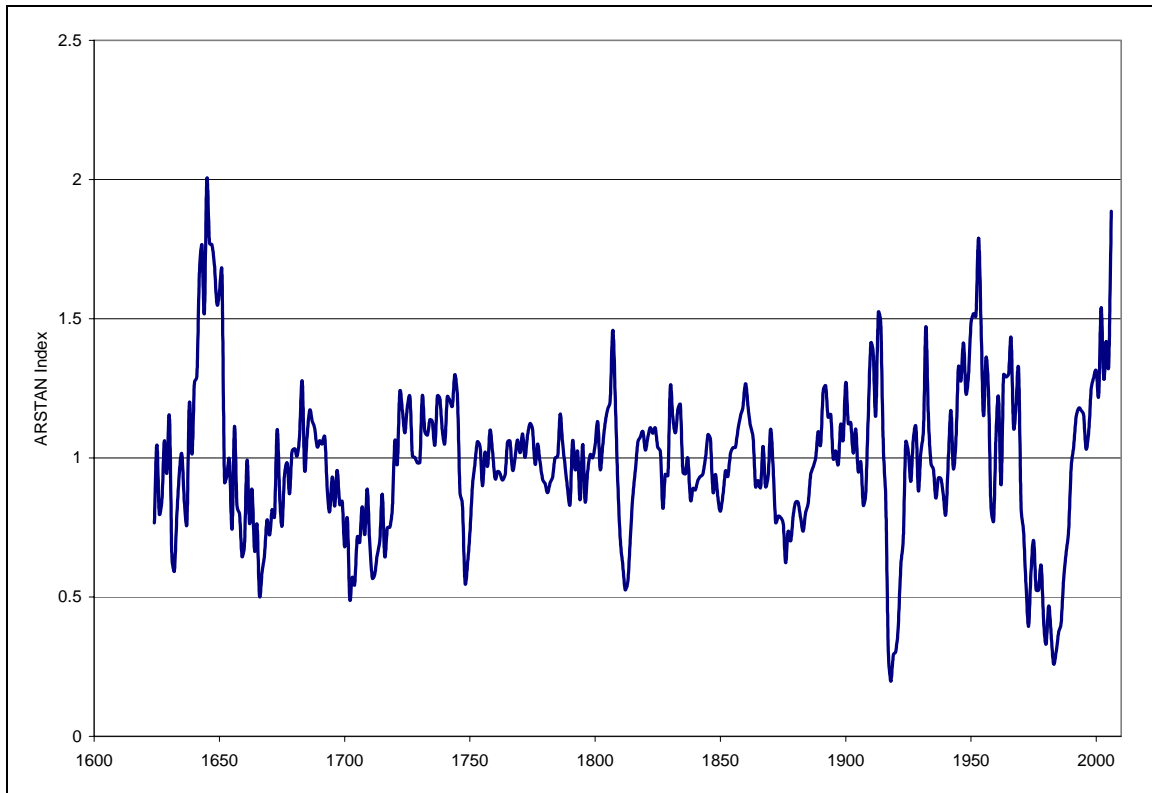
Figure 6: Combined master chronology for red spruce in New Brunswick and Nova Scotia.

By combining the master and church chronologies, it was possible to develop a master chronology for red spruce in New Brunswick and Nova Scotia (Figure 7). The overall correlation of this chronology is 0.479, which is much higher than the 0.3281 required for 99% confidence of significance.

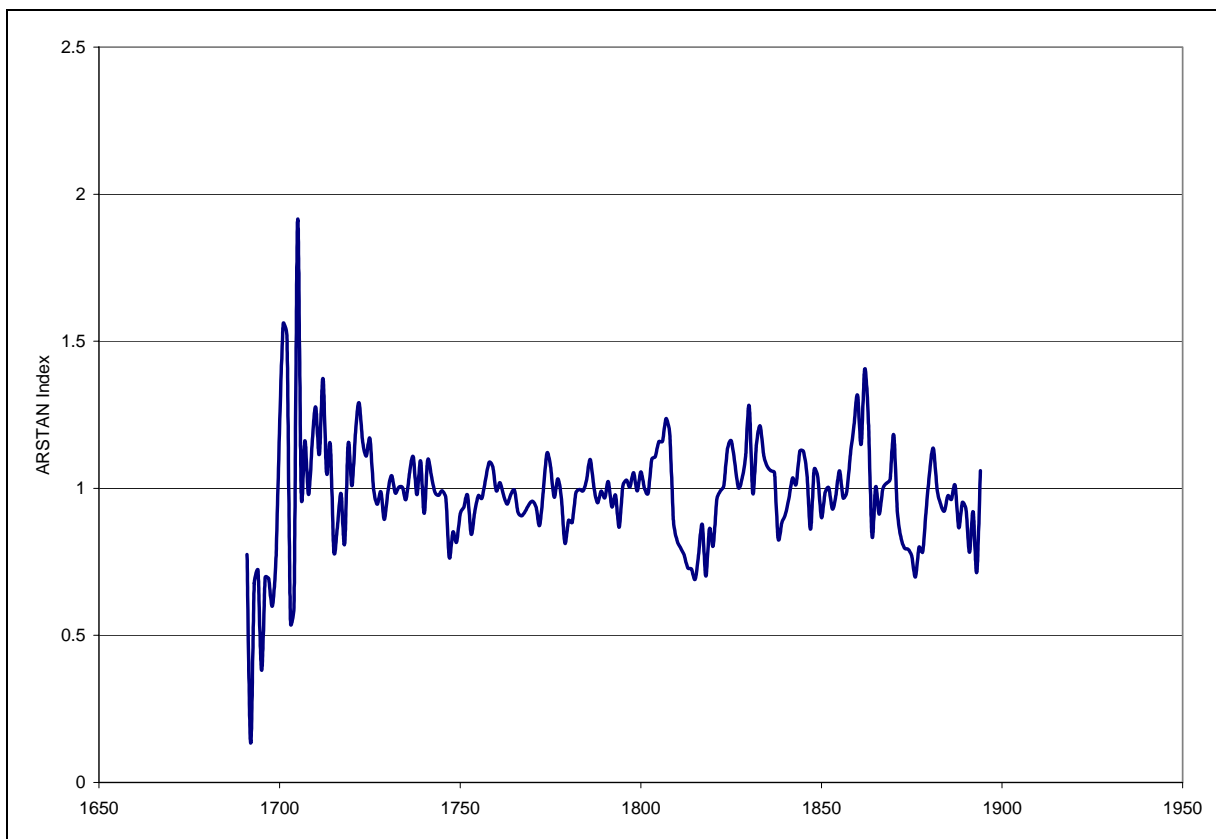
Figure 7: Master chronology for red spruce in southwestern Nova Scotia.

From the church chronology constructed from Zion Baptist Church as well as the chronologies constructed from the other churches sampled in southwestern Nova Scotia, it was possible to make a master chronology specific to the region (Figure 8).
