MAD Lab Report 2007-11

Dating the Dugas House

Felicia Pickard, Ben Phillips, Mary McQuaid, Nicole d'Entremont,
Andre Robichaud and Colin P. Laroque

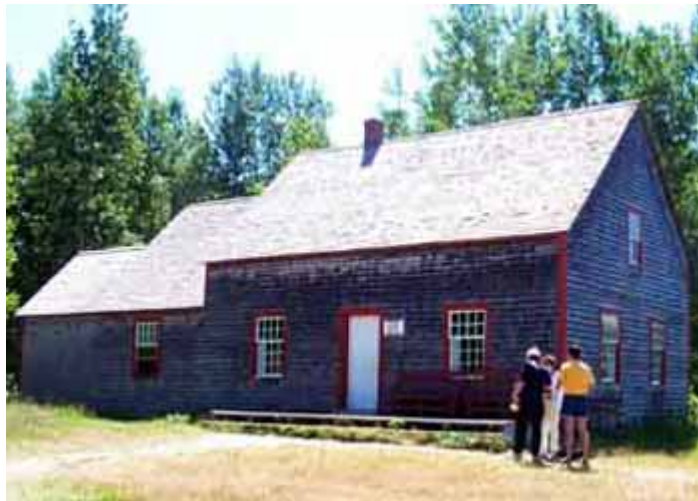
Figure 1: The Dugas House in the Village Historique Acadien, near Caraquet, NB.

In the summer of 2007, Mr. John Leroux approached the Mount Allison Dendrochronology (MAD) Laboratory in the hopes of finding or confirming construction dates for a particular structure on the VHA property, the Dugas House (Figure 1). This report describes the process that was undertaken to conduct this research.

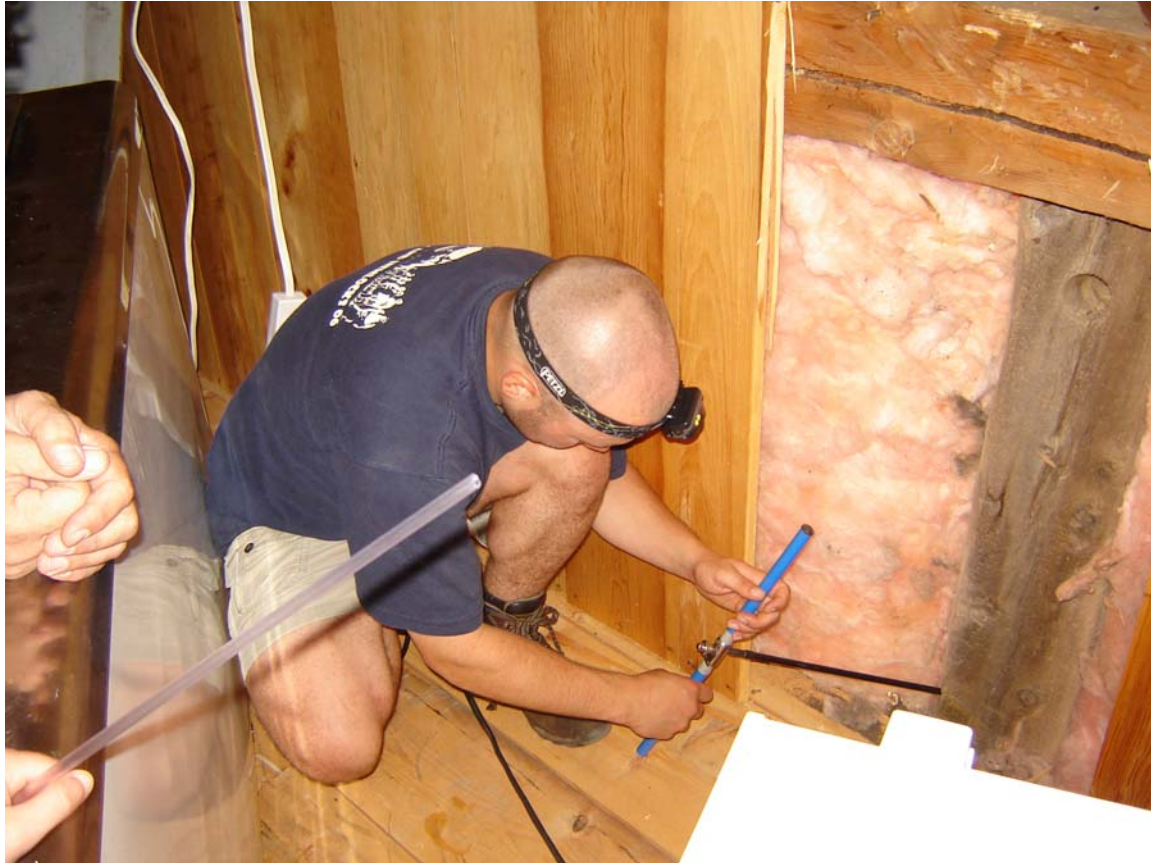
Figure 2: Openings in the paneling were created to gain access to ten main upright beams. A researcher is shown using an increment boring tool to collect a 4.3 mm sized dowel from the beam.

Ten increment core samples were taken from the Dugas House. The staff of the facility prepared openings to the main timbers in the structure by removing panels on the walls to provide access to the upright beams on the upper floor of the building (Figure 2). The cores were extracted using manual increment core-boring tools. A team of four researchers from the Mount Allison Dendrochronology (MAD) Lab, accompanied by VHA staff, sampled the building on July 27, 2007.
