Dickson House Tree-ring Measurements and Crossdating

MAD Lab Report 2013-11

Mount Allison University, Department of Geography and the Environment Mount Allison Dendrochronology Lab

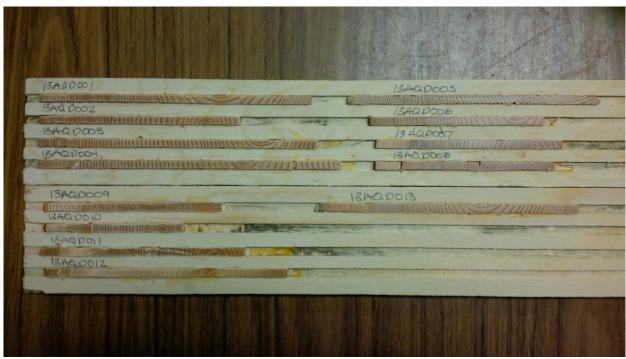
Figure 1: Core samples taken from the "Dickson House" structures. Cores were glued to a slotted mounting board and were sanded with progressively finer sand paper. Annual-growth rings are clearly visible after sanding.

Thirteen core samples were extracted from both of the Dickson House structures on Oct 7th, 2013. These cores were glued to slotted mounting boards before being sanded with progressively finer sandpaper grit: 80, 120, 220, 320, and 400 grit. In the end, the samples were very smooth and radial cell structure was clearly visibly under a microscope. Radial growth (the width of each tree ring) was then measured using a Velmex staging system with an X63 microscope, precise to 0.001 mm.
